**NTSB** National Transportation Safety Board

**M/V ETHAN ALLEN**

# Stability Safety Issues

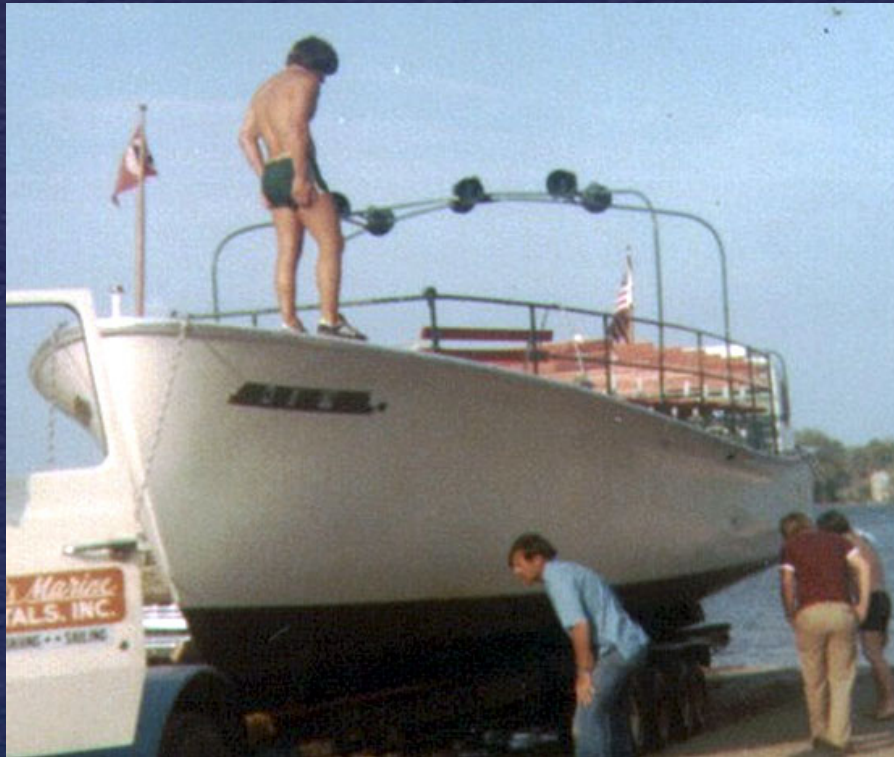
# Dyer 40-foot Hull - No Canopy

Photo from New York State

- *Ethan Allen* delivered in 1964-looked similar to photo of sister vessel, *Algonquin* (ex. *Sea Lyon*)
- Believed to have passed Simplified Stability Test (SST) for 48 passengers in 1966
- Two sister vessels delivered in 1966

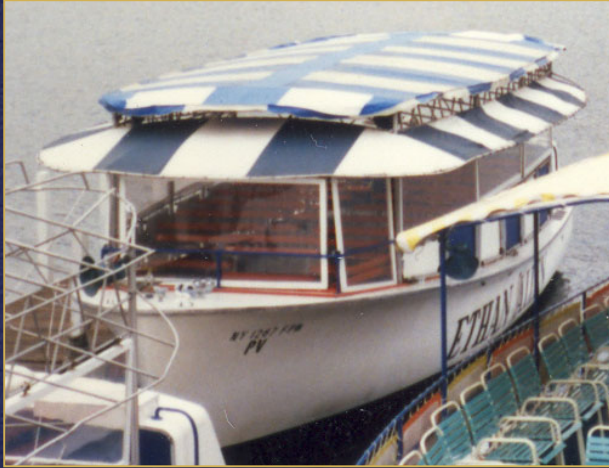
# Metal Framed Canvas Canopy

- *Ethan Allen* with canvas canopy originally installed in Groton
- Stability assessment not done nor required by USCG
- New York State accepted passenger loading data from last Coast Guard COI in 1979
- *De Champlain's* canvas canopy installed at Lake George
- Stability assessment not done nor required by New York State

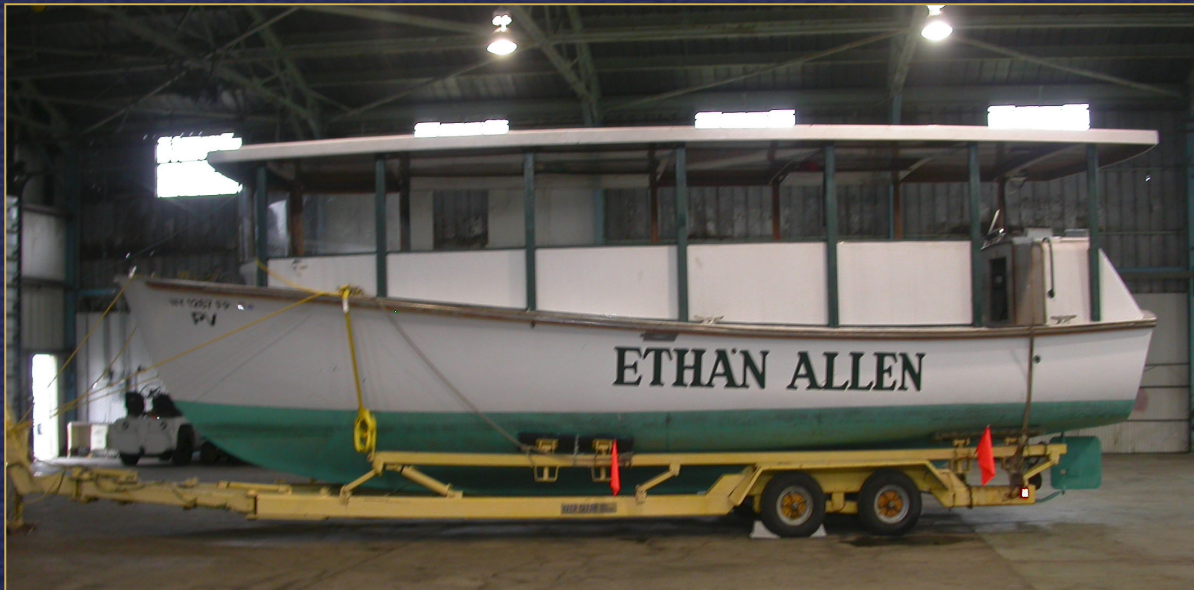
# Wood Canopy

- Wooden canopy replaced canvas canopy on the *Ethan Allen* in 1989
- *De Champlain* and *Algonquin* new wooden canopies installed in 1990 and 1991, respectively.
- No stability assessment done following these modifications.

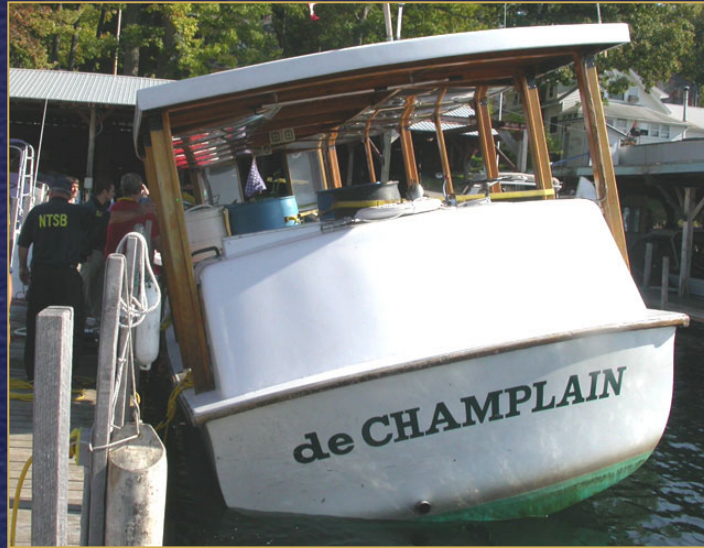
# Post Accident Testing Results

- *De Champlain* failed on scene SST for 48 passengers
- *De Champlain* inclined to obtain vessel characteristic

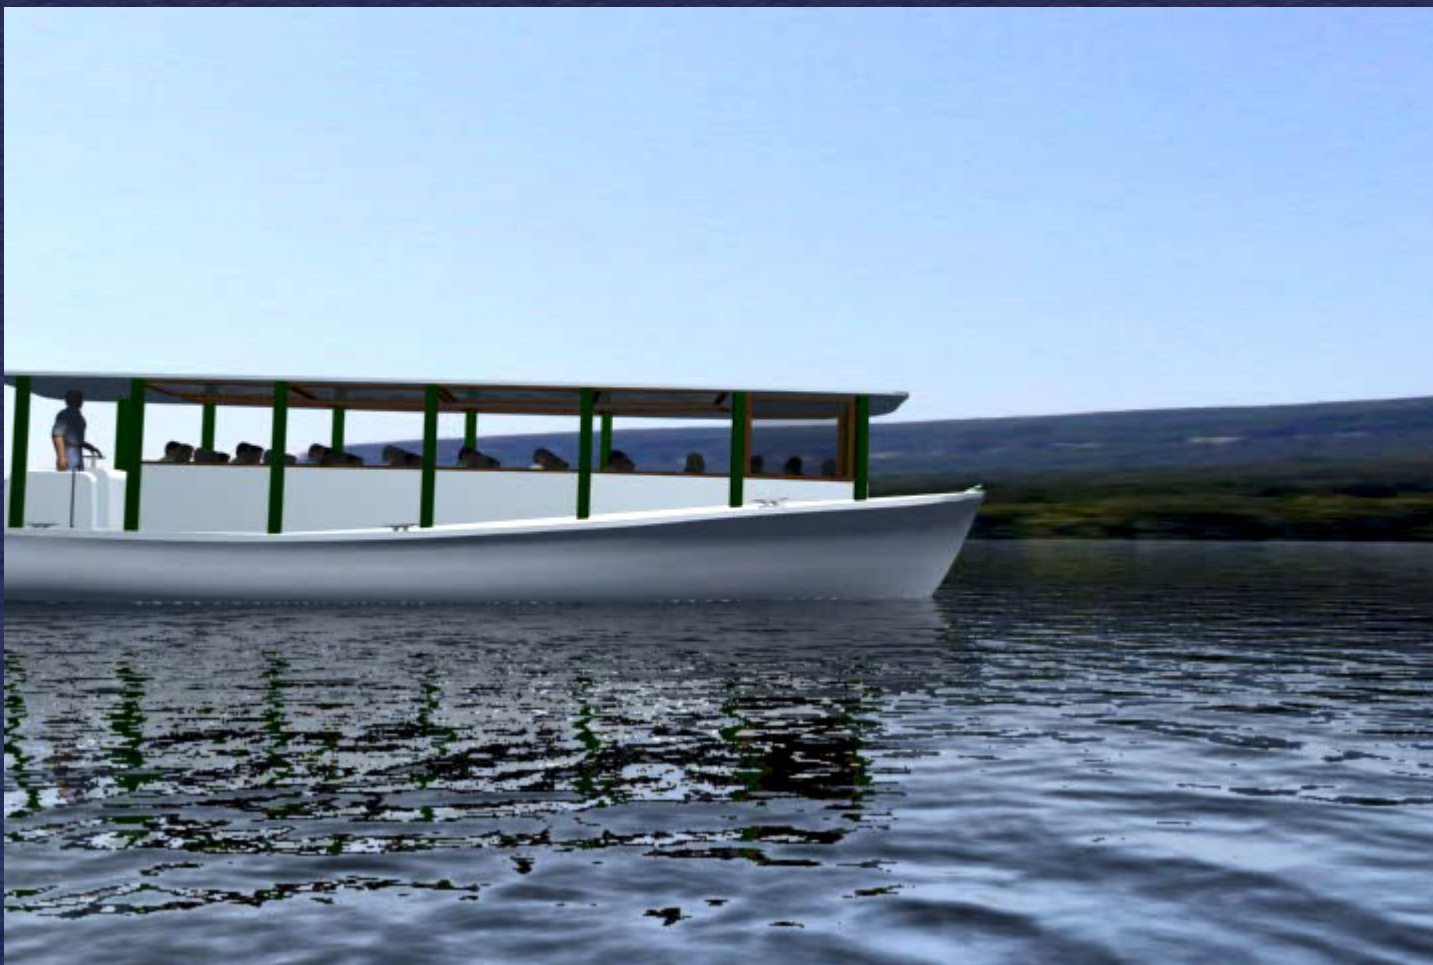
Initial trim by the bow

- Following slides represents staff's scenario of capsize
- Based on testimony, examination of the vessel, and the results of the stability study

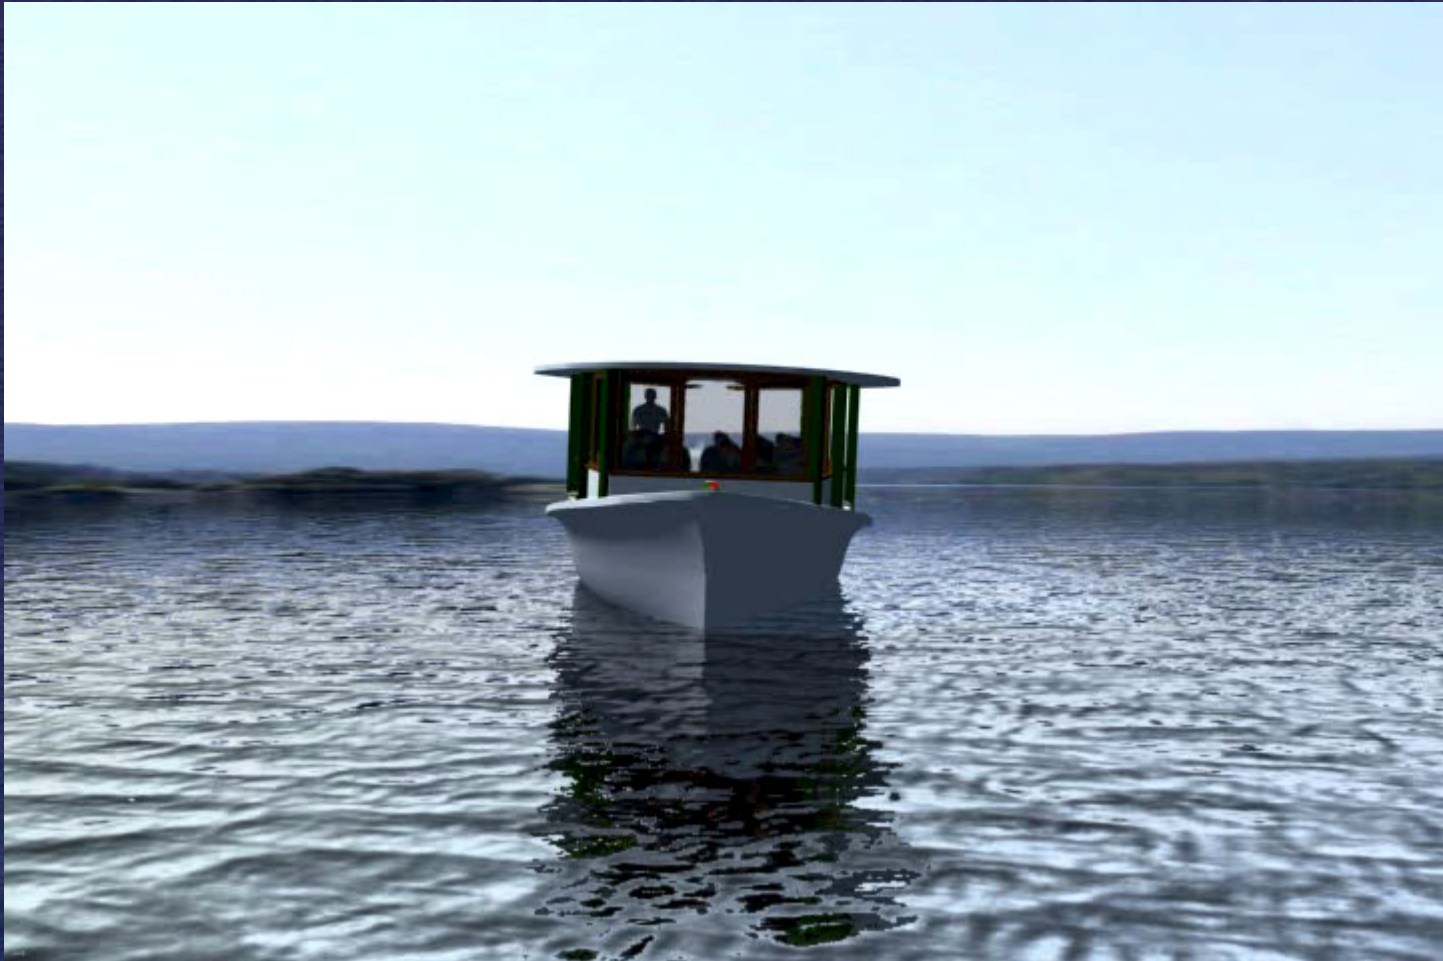
Initial heel 2 degrees to port

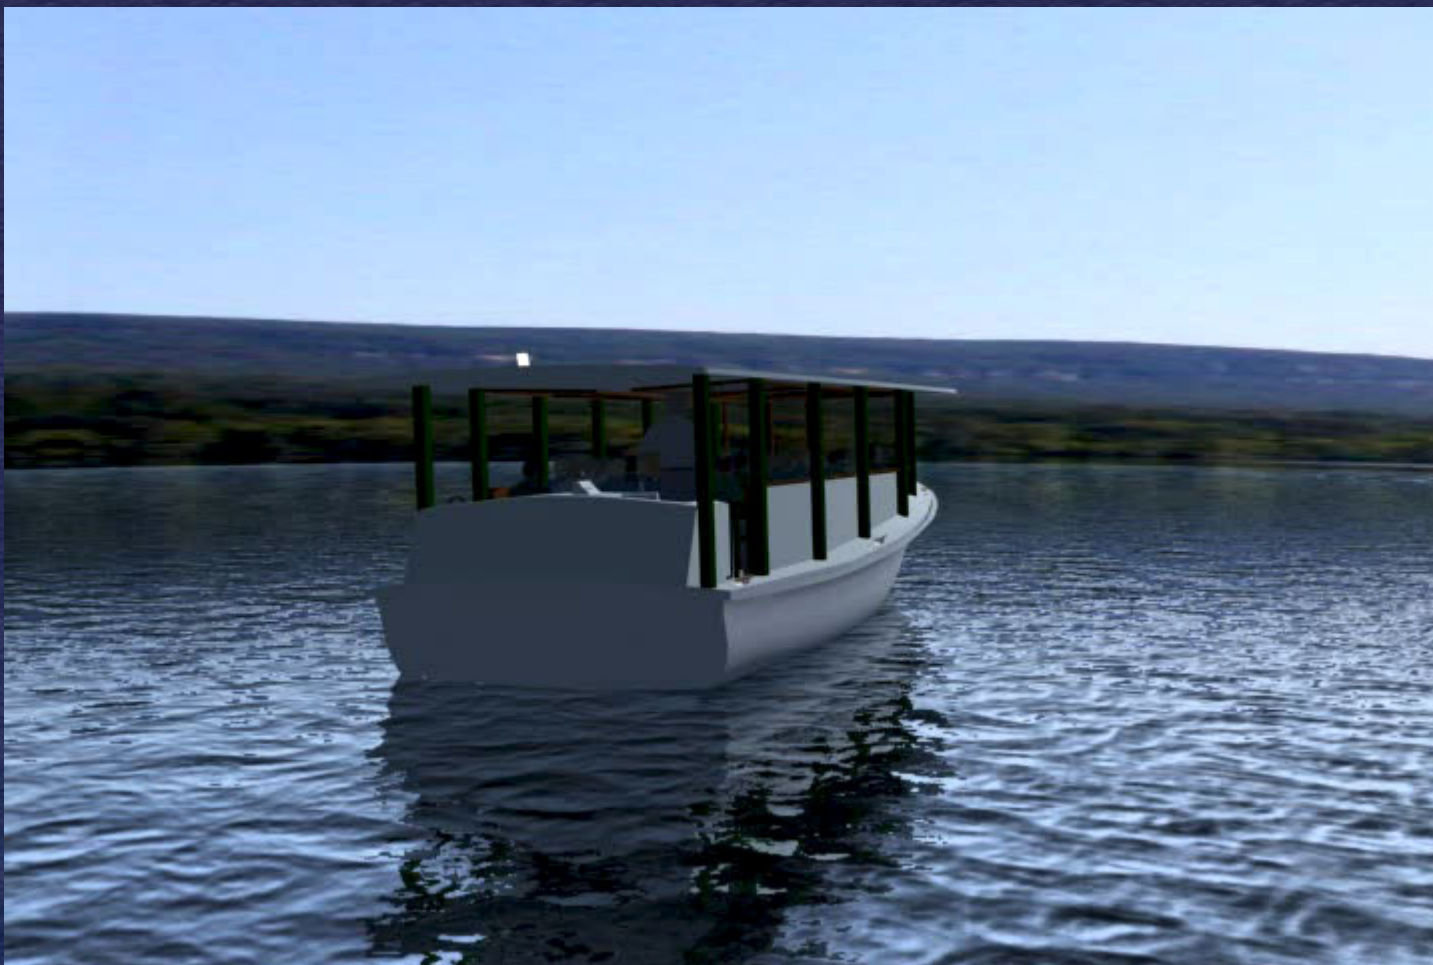
Approaching waves

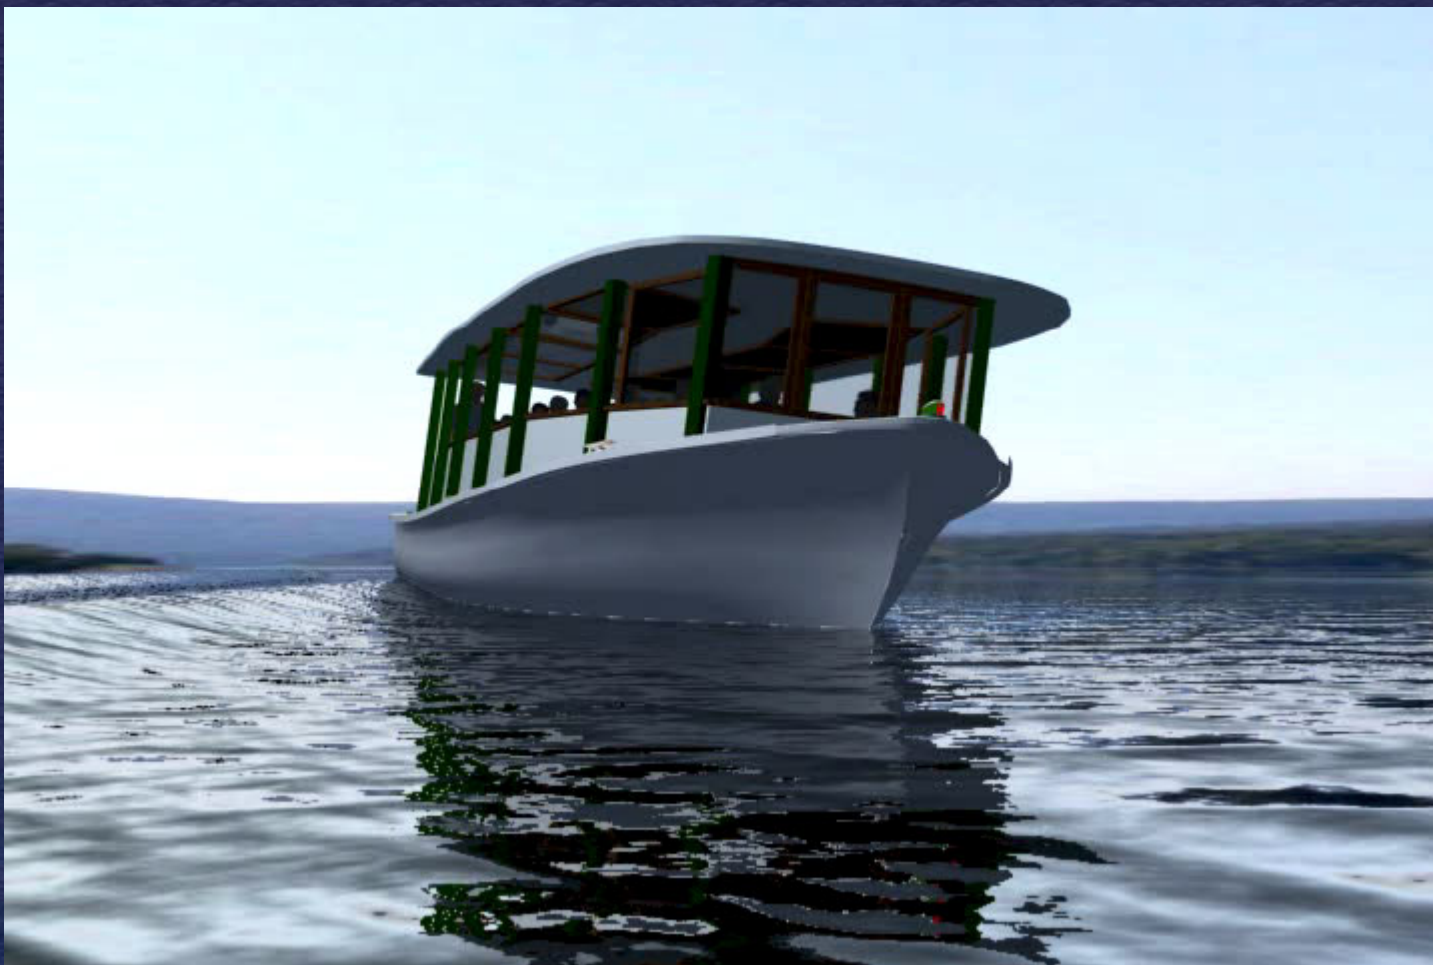
Wave or waves roll vessel further to port

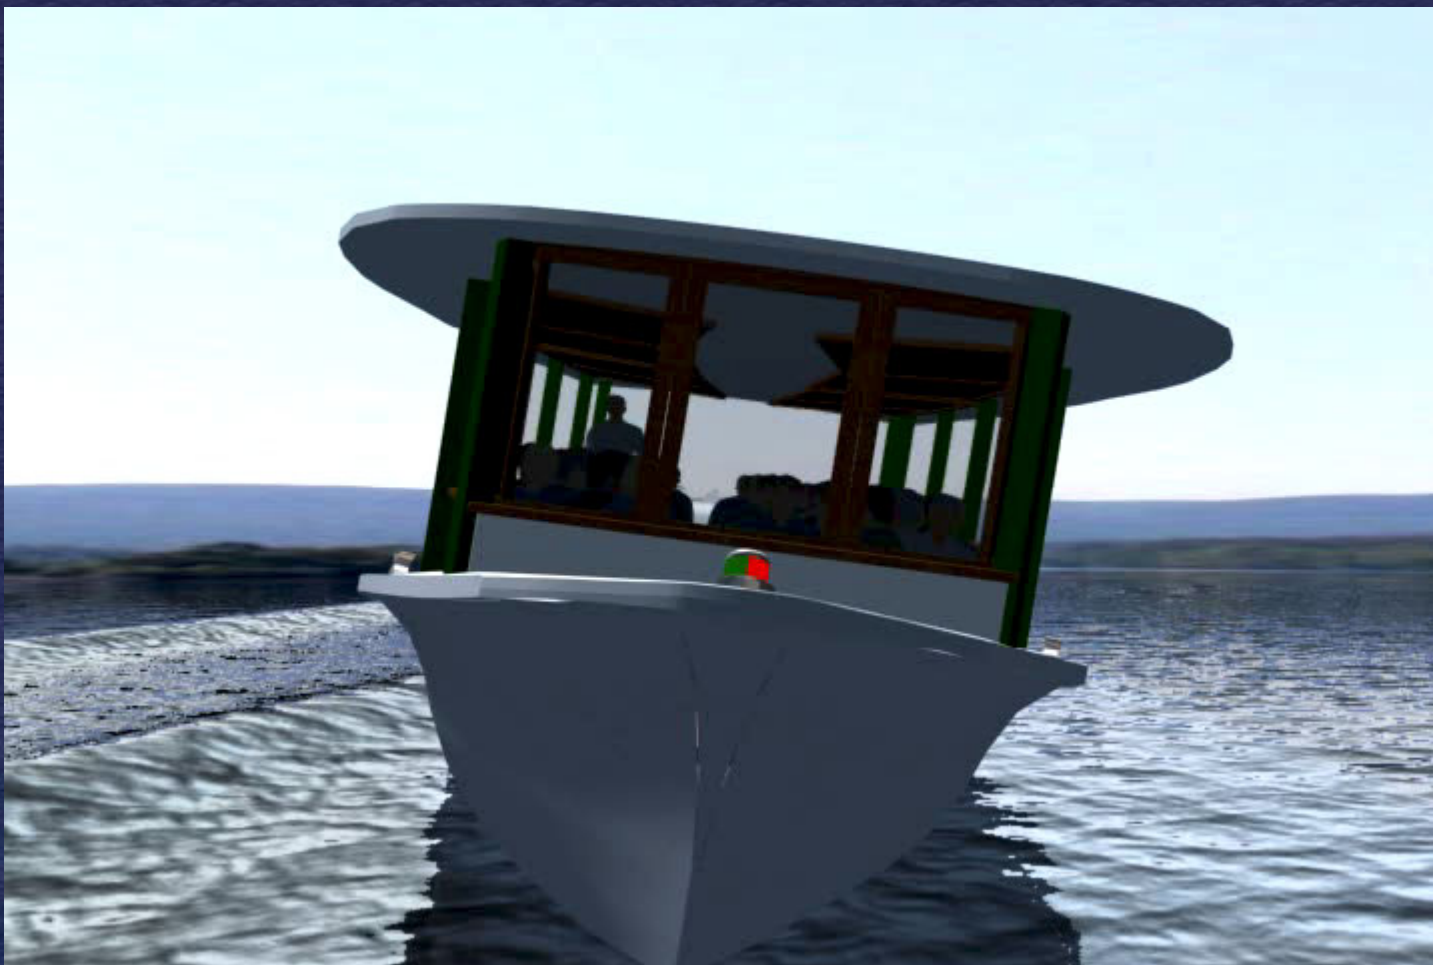
Port roll causes passenger shift
